The undrained cohesion of the soil as a criterion for column installation with a depth vibrator

J. Wehr

Keller Holding GmbH, Offenbach, Germany

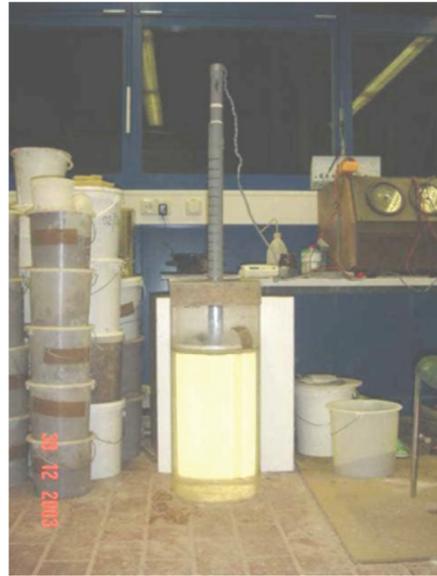
Figure 1. PVC container.

A PVC container with an inner diameter of 29 cm and a height of 60 cm was filled with silt up to a height of 50 cm, see Figure 1.

In order to install the sand columns, a PVC-tube with an outer diameter of 5.0 cm and an inner diameter of 4.6 cm was used. This PVC-tube replaces the vibrator and follower tubes which have a diameter of approximately 40 cm in reality. The PVC-tube is necessary to keep the hole open dur-

ing sand filling, because no water or pressurized air is used as in reality.

To model the vibrations of a real vibrator, a small vibrator was fixed to the lower end of a second PVC-tube ("vibrator tube") with an outer diameter of 4.5 cm. The vibrator tube fits exactly into the first tube. Horizontal vibrations were applied. Details are given in Table 2.

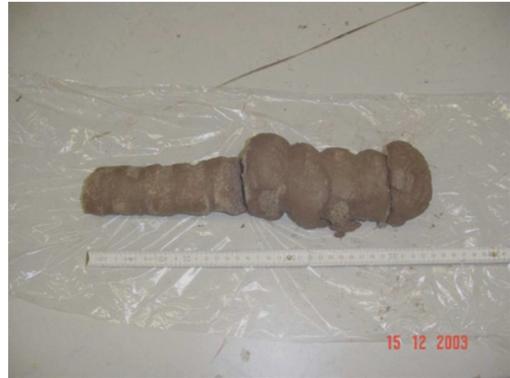
Figure 2. Column with $c_u = 3.5 \text{ kN/m}^2$, where failure has occurred.

In this test the water content was again raised by 1.5%. Here failure was observed with an enlargement of the diameter by 100%, see Figure 2. The closer the installation comes to the surface the smaller are the stresses acting as soil resistance and the faster failure is reached.
